## Crossover Readings on GP20

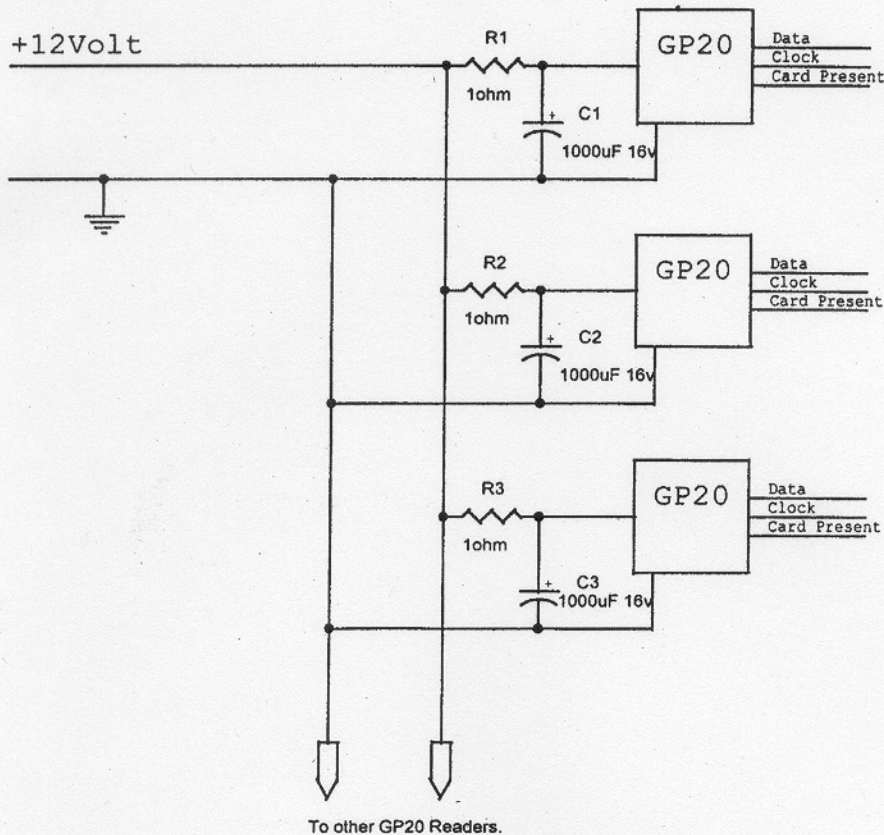
The second cause of 'echoing' can occur where it is required to operate two or more GP20 readers on the same local DC supply. If the supply is not sufficiently smoothed it is possible for any RF field in the lead of one reader to travel down the cable and appear at the other reader/s and cause a read. (Echo)

The effect happens most where the DC supply wires are connected in common in the field and not taken back to the low impedance DC supply on the controller.

One solution that is very effective is to decouple the DC supply lead to the readers as below.
